Transport
Canada

TP 6980E

**AGING
AIRCRAFT
Part IV**

Canadian Aviation Service Difficulty Reports

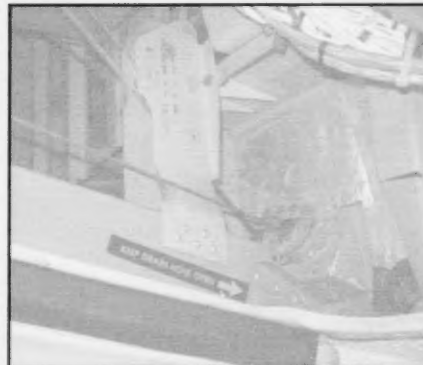
The primary cable for the elevator control had jumped out of its respective pulley. The "spring pin", P/N NAS 427K6, that prevents this from happening was out of position, and therefore was unable to stop the cable from leaving the pulley.

This defect subsequently caused abrasion of the elevator cable on the surrounding support structure. The support structure is a short distance from where the elevator cable emerges from the pressure vessel as it travels aft to the bellcrank.

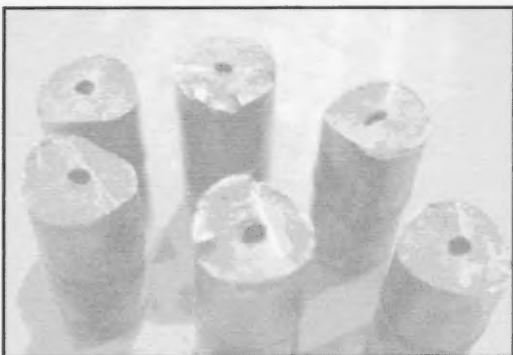
SDR # 20050228002

Wheel Dowel Pins Cracked

During a tire change, an inspection was being carried out on the wheel, P/N 215850026. Six (6) of the dowel pins, P/N 20209, used to align the rim halves were found sheared or cracked.

The cause is undetermined but this is a good reminder to complete a thorough inspection at each tire change. ✖

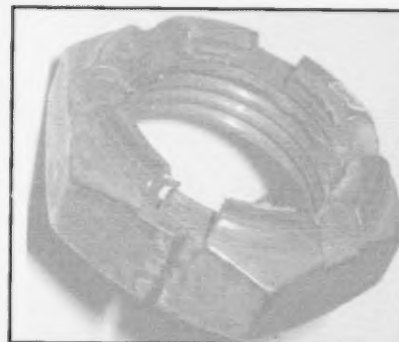
Wing Strut Attachment Bolt Cracked

During corrosion protection corrosion control (CPCP) and the supplemental inspection document (SID) inspection, the wing lower attach strut bolt and nut were removed for inspection and the nut was found fractured through.

The cotter key should hold the nut/bolt in place. The fracture was located through the manufacturer's identification stamp on the outer surface.

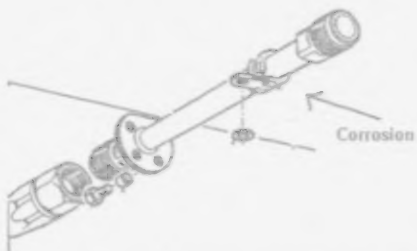
DE HAVILLAND DHC-6 100

What s That Smell!

Investigation into a "fuel smell in the cabin" and a minor external fuel leak revealed that the welded fuel tube assembly, P/N C6PF10761, between the fuel tank and the flex hose to the wing strut, was leaking.

Removal of the Adel clamp revealed corrosion pits underneath, with associated fuel seepage. Investigation into the opposite side assembly revealed a similar condition, but the corrosion was not advanced enough to cause a leak. Both tube assemblies were replaced and the aircraft returned to service.

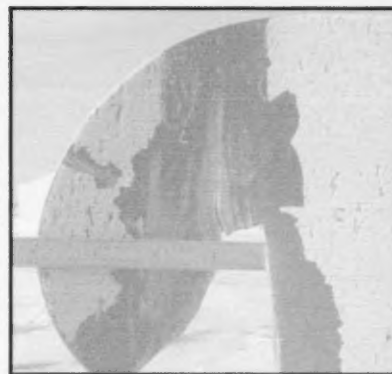
Runway Debris - Aircraft Damaged

Subsequent inspection revealed that a section of the propeller tip penetrated the fuselage just behind and below the airstair door. Additionally, a 3-inch hole was found on the opposite right propeller spinner. Smaller sized stones (aggregates) were found within the spinner.

During winter operations, it is suspected that this damage was caused by the larger sized (1.5 inch) aggregates that were spread on the runway rather than the much smaller and finer aggregates.

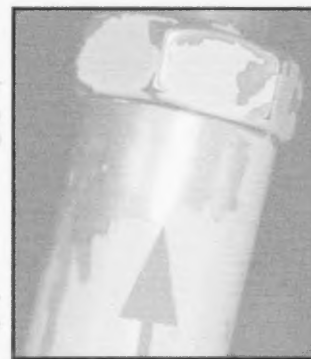
SDR # 20050125017

Collective Tube Assembly Cracked

The AME was preparing to grease the swashplate. To access some of the zerk fittings, it is easier to lift up the collective control stick. The AME was moving the collective control stick up when the ridged tube, P/N 212001181001, bent and broke in two. The breakage occurred between the two throttle grips where there is a slot in the tube for the throttle control.

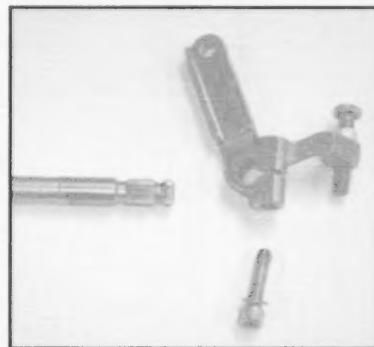
Closer inspection of the setscrew revealed a flat spot on it where the shaft had been wearing into the screw, due to the fact it was loose. The linkages were re-installed and an engine run-up was carried out serviceable.

The FCU was changed as a precautionary removal.
